SERVICE REPORT FOR MV TYCOON

SERVICE REPORT

Vessel Name: TYCOON

Job Description: ME MAN B&W 5S60MC -C No.3 crank pin repair

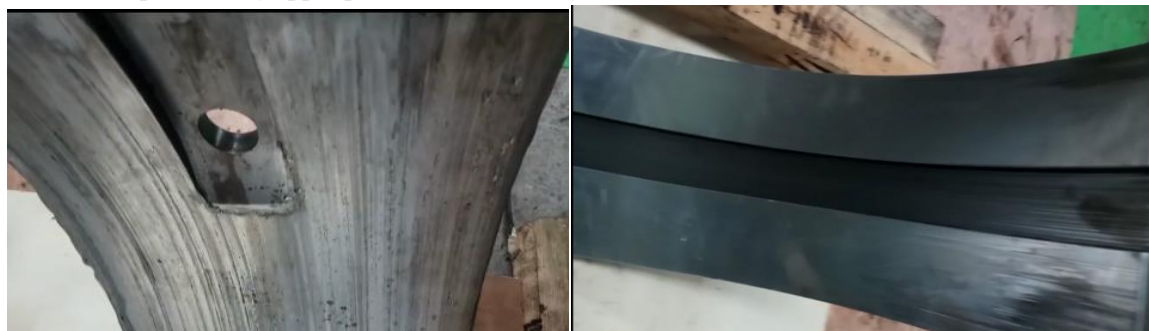
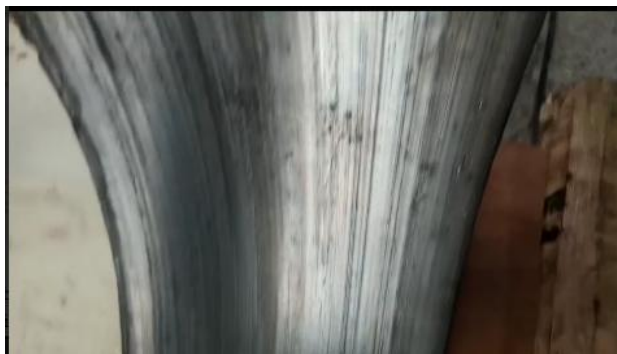
c. Crank pin bearing

Used crank pin bearing upper part worn seriously, also need machine.

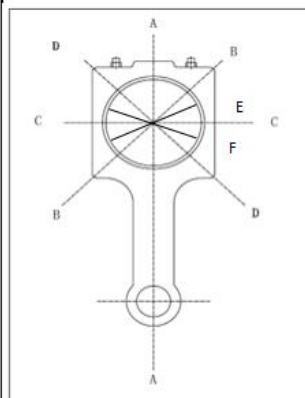
Final inspection for connecting rod big end with bush:

编号 NO.	大端孔径 BIG END	测量方向 MEASUREMENT	前端 FORE	后端 AFT	编号 NO.	大端孔径 BIG END	测量方向 MEASUREMENT	修理前公差 INITIAL INSPECTION	修理后公差 FINAL INSPECTION
3#	φ718	A-A	+0.42	+0.41			A-A		
		B-B	+0.41	+0.42			B-B		
		C-C	+0.57	+0.60			C-C		
		D-D	+0.42	+0.42			D-D		
		E-E					E-E		
		F-F					F-F

Standard clearance: 0.40-0.64mm
